Corporate On Going Project: Social Responsibility to Global Semiconductor Industries.

Social Responsibility: Responsible to the green planet earth by reducing waste and recycling wire bond capillary.

WB Capillary Cleaning / Refurbishing

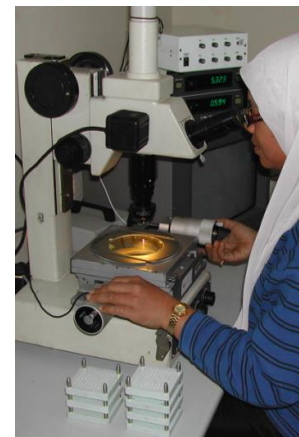
Unplugging & Cleaning Process

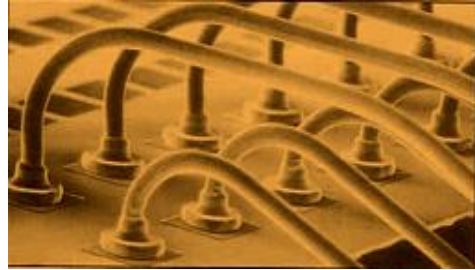
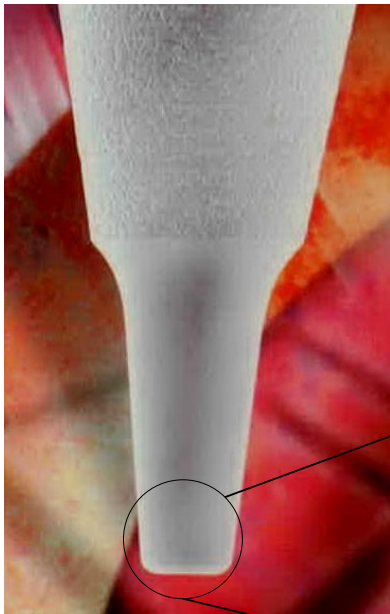
Typical narrow angle
"bottle neck" capillary

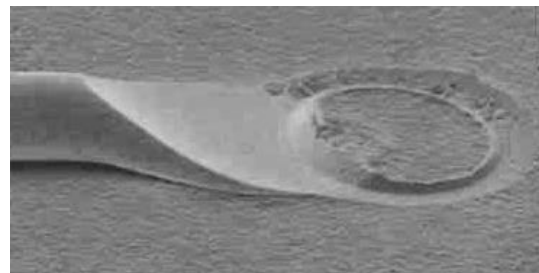
Good Second "stitch" bond

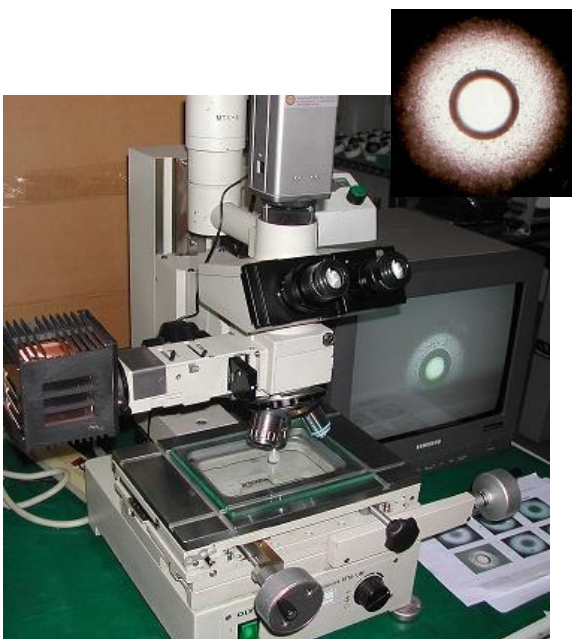
High Power Microscope

Also critical is the final inspection of the cleaned capillary using a 400-500X magnification high inspection microscope. This microscope will also have the CCD attachment for inspection report and record.
